Summary

Inspected By: Tim O'Neill, ACI #38600

Inspection Date: 10/10/2022

**Inspection Address
123 E. Main Street
Phoenix AZ 85142**

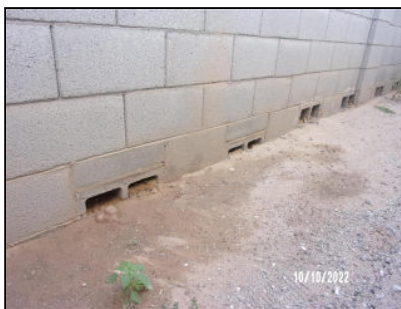
1.0 Grading/Drainage

Suggest monitoring the east site drainage performance, confirmation of the flow path of surface water was not made by visual observation - Review/Consult Seller.

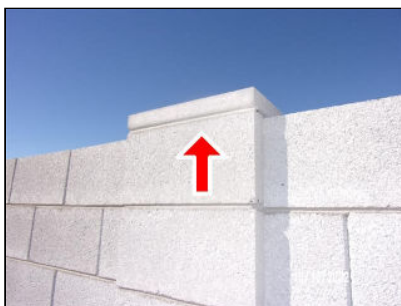
1.5 Fence

Loose column cap block(s) were noted at the fence - Review.

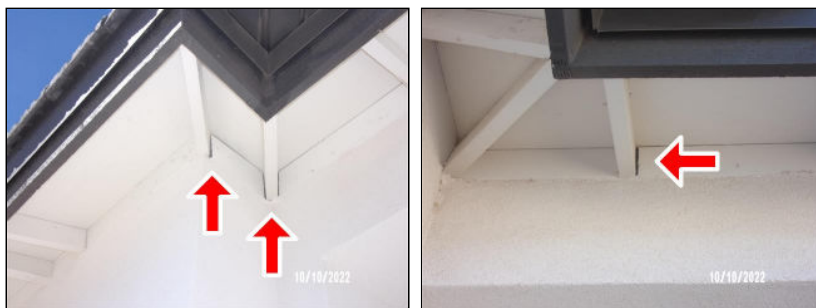
(1) Caulk/seal **all** gaps, cracks and openings at the exterior walls - Review.

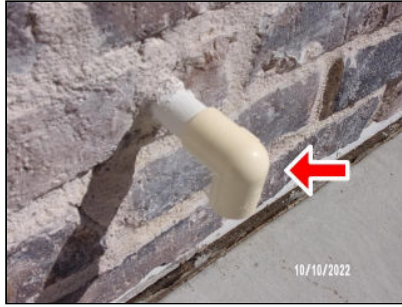
(2) Unpainted cpvc noted at the south exterior - Review.

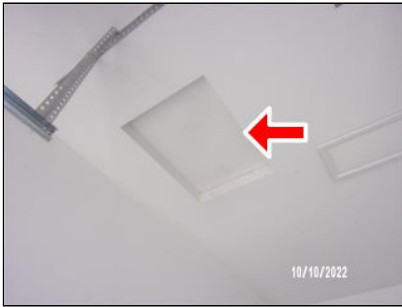
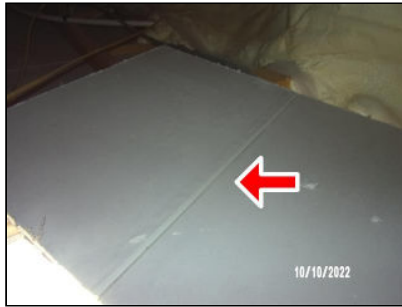
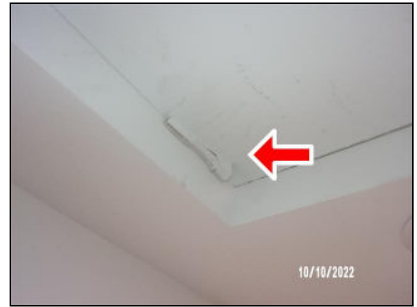
3.0 Attic Observations

Cracked/damaged attic access covers noted at the small garage and interior locations - Review.

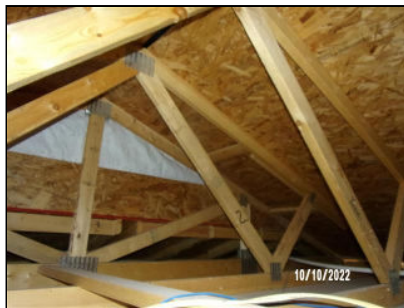
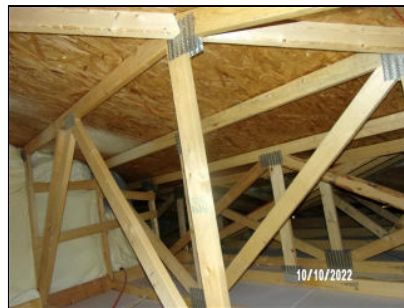
3.4 Attic Ventilation

No ventilation found at either of the garage attics - Attention.

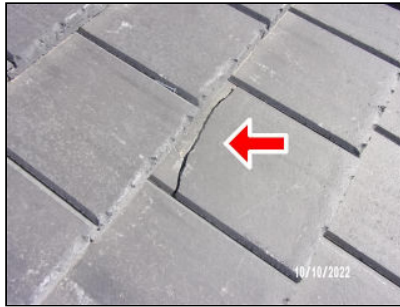
4.0 Concrete Tile Roof

One cracked roof tile found above the small garage - Review.

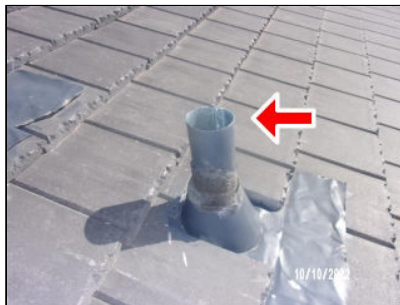
6.1 Dryer

The exterior dryer vent cap was missing - Attention.

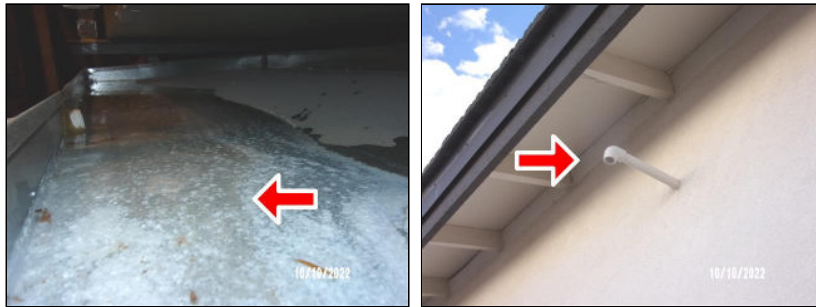
8.4 Condensate Issues

The secondary condensate pans in the attic and the secondary condensate line are in use which indicates an issue - service/evaluation is required - Attention.

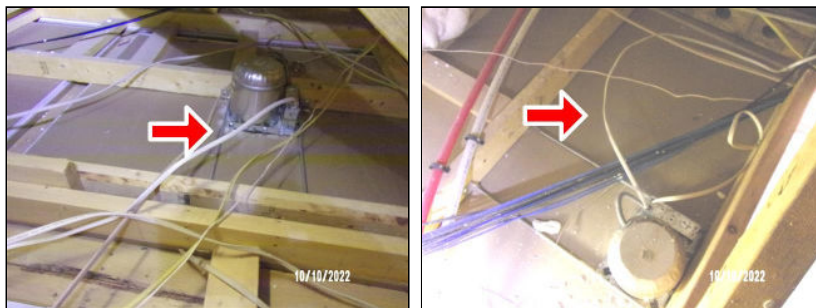
9.4 Distribution System Components

(1) Some romex cables in the attic are not properly secured at the light fixtures - Review.

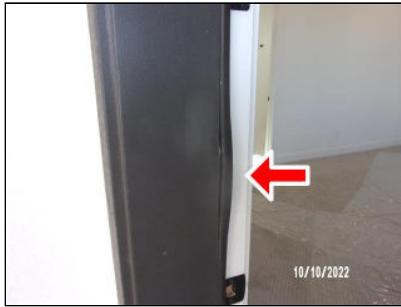
10.0 Exterior Doors

- (1) The patio arcadia door track needs cleaning - Review.
- (2) Loose exterior door hardware noted at the entry - Review.
- (3) Exterior door weatherstrip was loose/damaged at the master b/r - Review.

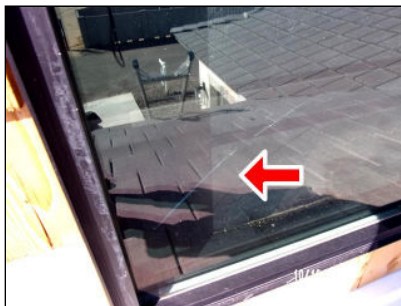
10.4 Windows

- (1) Window difficult to operate at the kitchen - Review.
- (2) Cracked window glass noted at the roof level window - Attention.

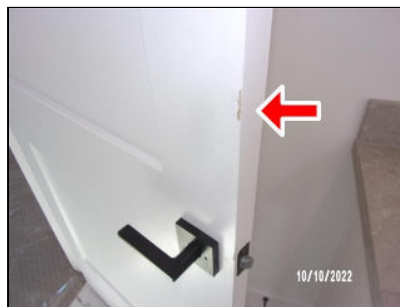
10.10 General

Fit/finish not yet complete at some areas around the house - Review.

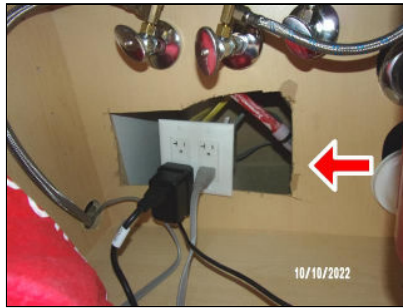
11.0 Cabinets

Hole/loose outlet found under the kitchen sink - Attention.

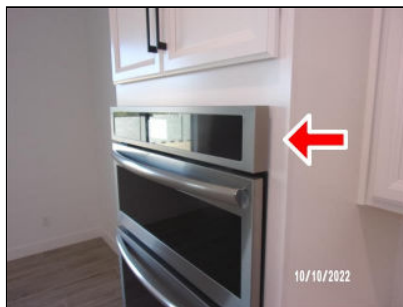
11.6 Range-Oven

(1) Loose oven control panel noted - Review.

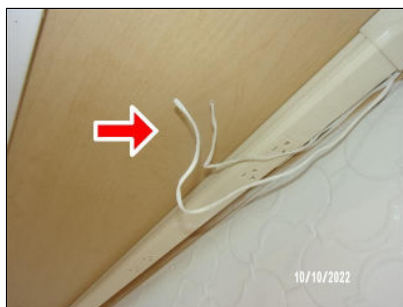
11.9 General

Exposed low voltage wires noted at the under cabinet kitchen lights - Review.

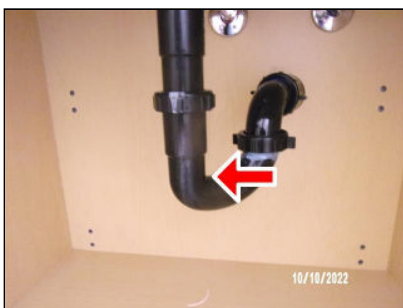
12.2 Sinks

- (1) Evidence of past leakage noted under the left side east bathroom sink - Monitor.
