## Inspection Report

**Property Address:  
123 W. Main Street  
Phoenix AZ 85020**

**Inspected By: Timothy O'Neill, ACI**

<b>Date:</b> 2/20/2023	<b>Time:</b> 12:00 PM	<b>Report ID:</b> 022023Main
<b>Property:</b> 123 W. Main Street Phoenix AZ 85020	<b>Customer:</b> Business Buyer	<b>Real Estate Professional:</b> Benjamin Hernandez

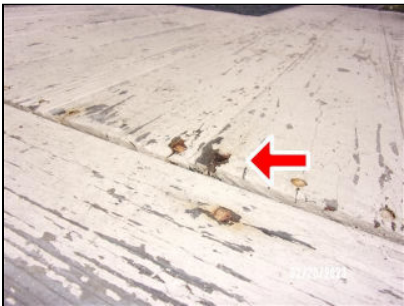
(1) Damaged paint noted at the front stairs/deck - Review.

(2) Lifted/loose nails noted at the deck(s) - Review.

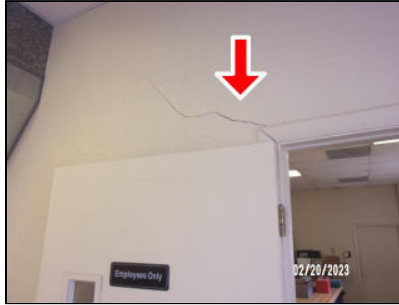
Possible expansive soil noted at the property due to uneven floors and various interior and exterior cracks found - Review.

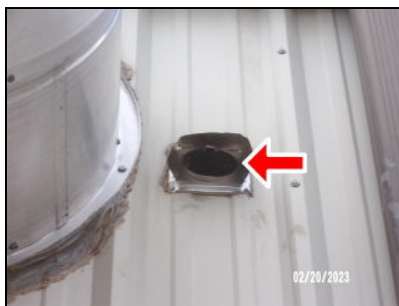
(1) Damaged/missing flapper sidewall vents noted - Review.

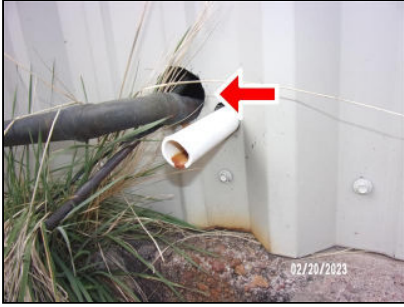
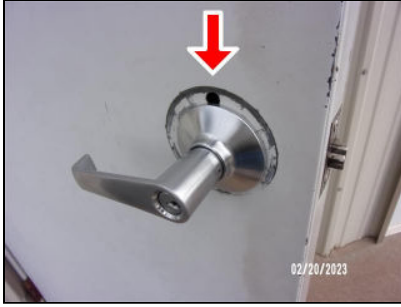
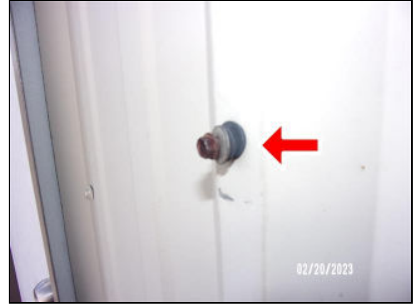
(2) Caulk/seal **all** gaps, cracks and openings at the exterior walls - Review.

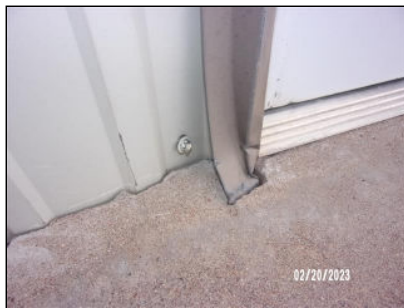
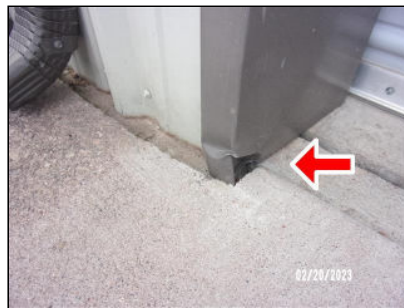
Damaged metal trim noted - Review.

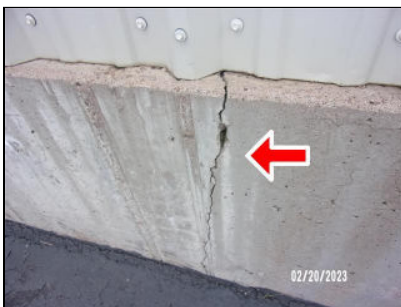
(1) Moderate stem wall cracks found - Review.

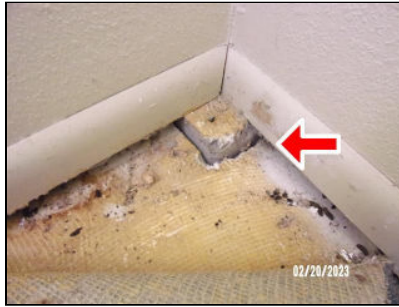
(2) Slab issues were found at several locations - Attention.

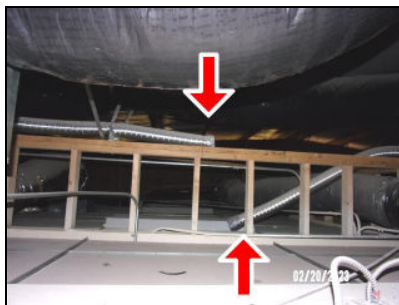
Vent tube(s) are separated within the attic - Attention.

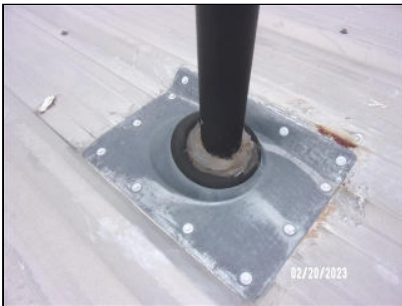
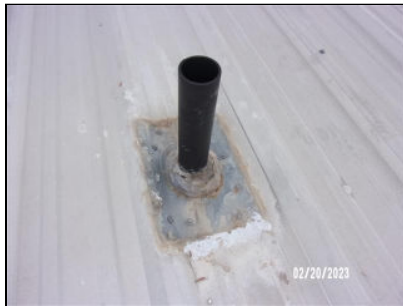
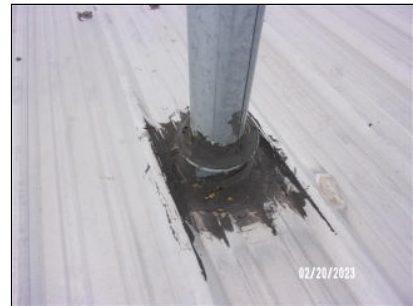
(1) Prior patching noted at the roof flashings - Review.

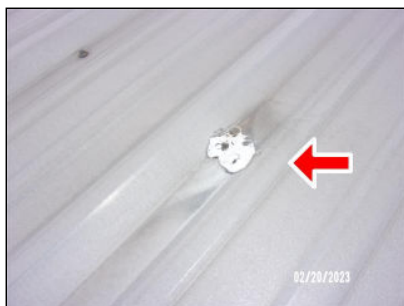
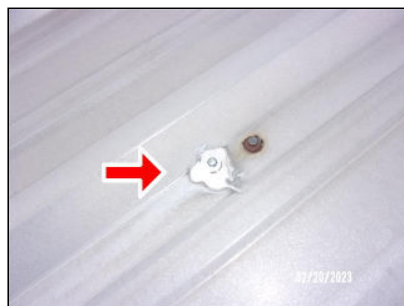
(1) Prior roof repairs evident - Consult Seller/Review.

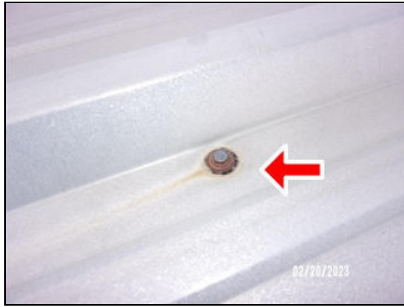
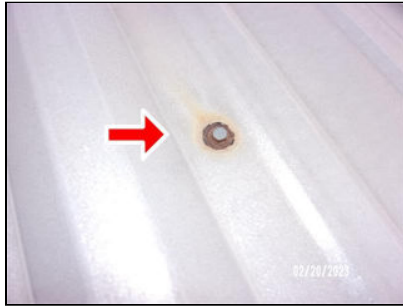
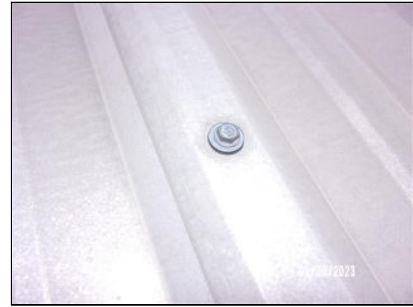
(2) Many rusted/damaged grommet screws noted at the metal roof need attention - Attention.

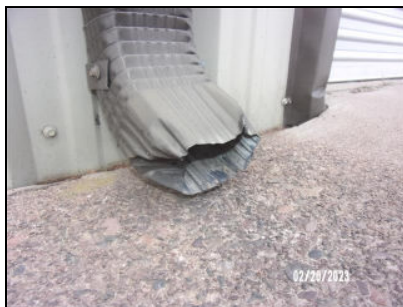
(1) Some damage noted at the gutters - Review.

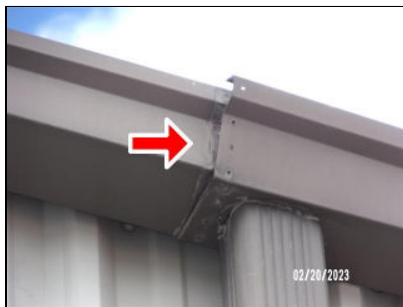
(2) The roof gutters need service (i.e., cleaning, sealing seams, securing as needed and aligning them to drain properly) - Review.

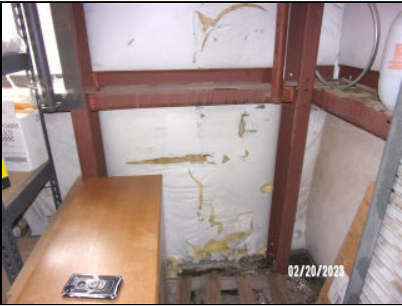
Damaged insulation found at the garage walls - Review.

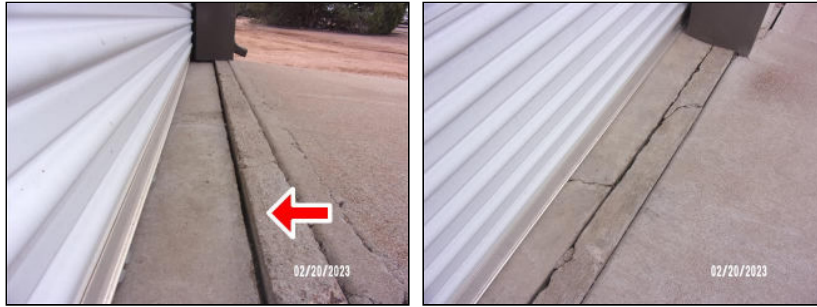
Offsets found at the garage door openings - Review.

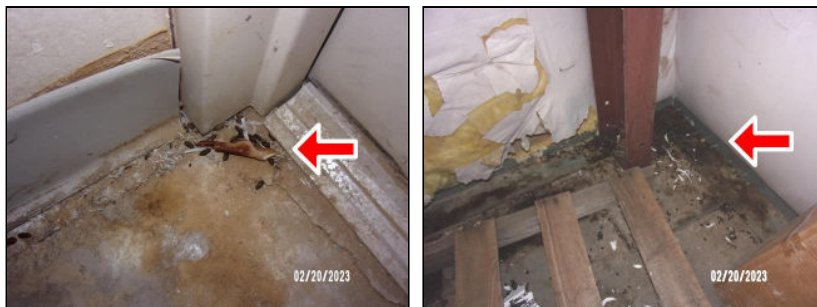
(1) Many rodent/rat droppings found - Attention.

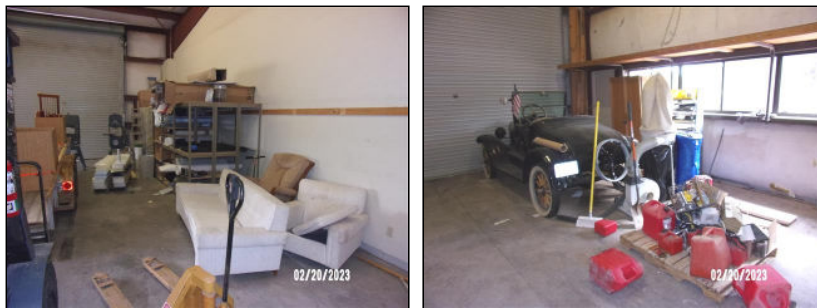
(2) Possessions prevent a full inspection of the garage - Review.

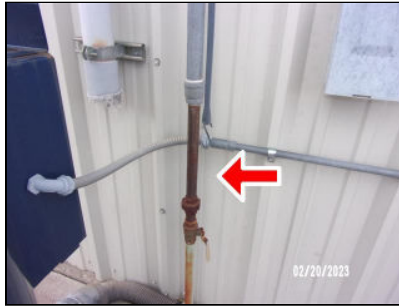
Rusted main gas pipe noted at the east exterior - Review.

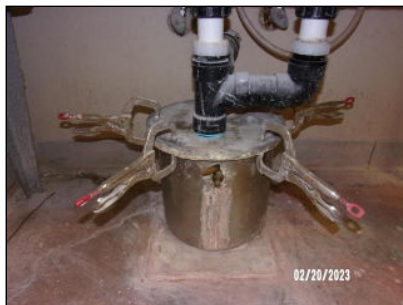
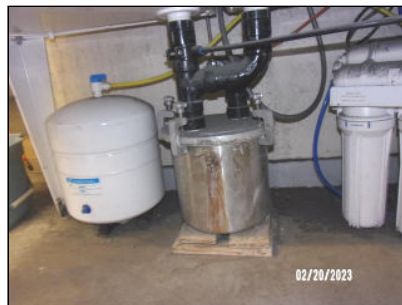
(1) Unusual sink drain traps should be accessed by a plumber - Review.

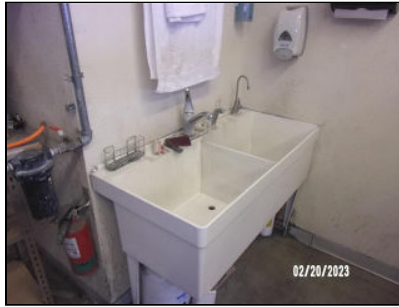
(2) Low flow hot water noted at the central sink - Review.

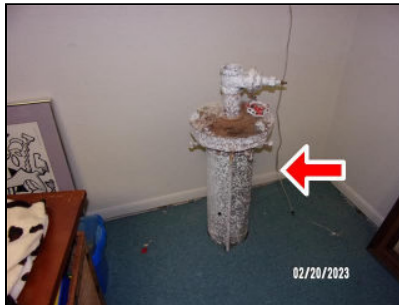
(3) Fire sprinkler main noted in the NE office - Review.

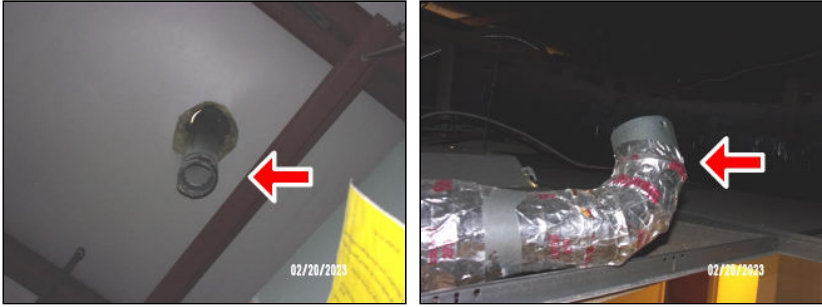
Separated/damaged flue pipe noted above the production room - Attention.

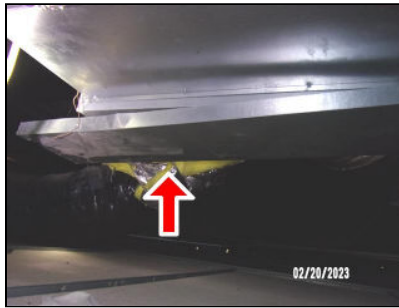
(2) The condensate pan above the production room is not sloped to drain correctly - Attention.

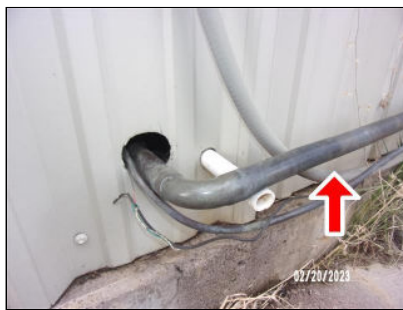
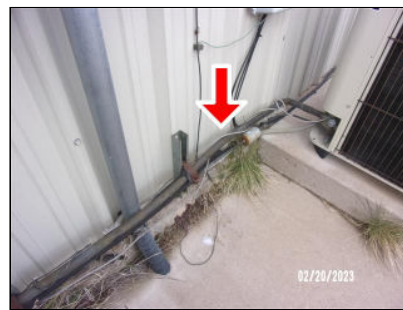
Insulation was missing from the cooling system refrigerant lines, install as required - Review.

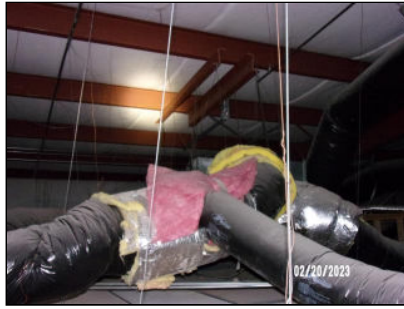
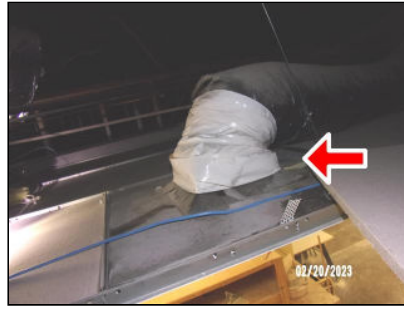
(1) Many repairs noted at the HVAC ducts - Review/Consult Sellers.

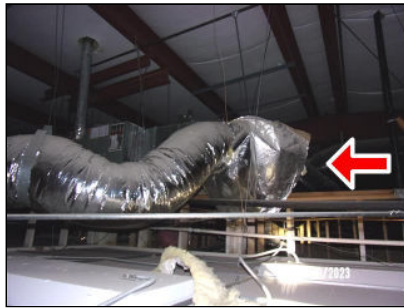
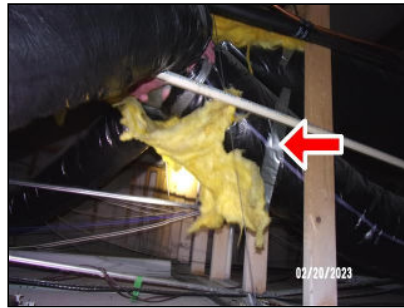
(2) Loose/unsecured duct insulation noted - Review.

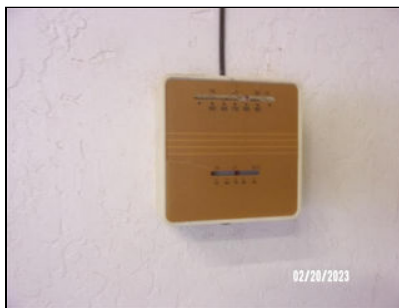
(1) Older garage thermostat noted - Review.

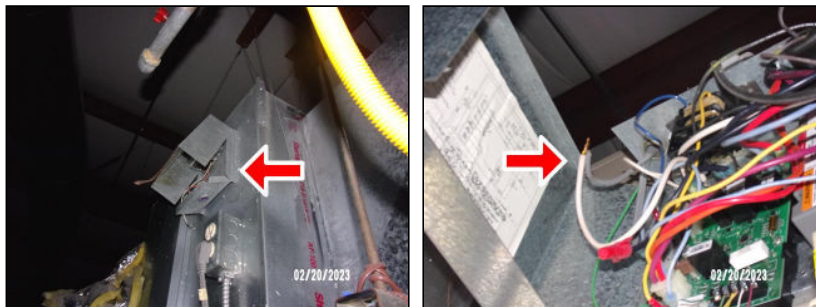
(1) Open covers/exposed wires noted at the attic HVAC units - Review.

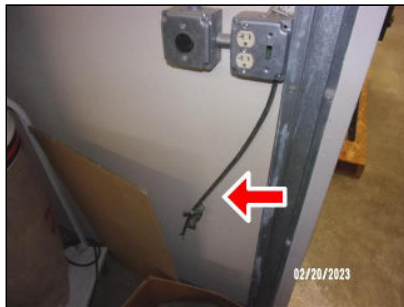
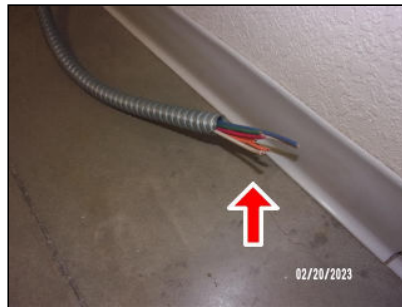
(1) Exposed wiring terminations were observed which need to be contained in an enclosed junction box - Attention.

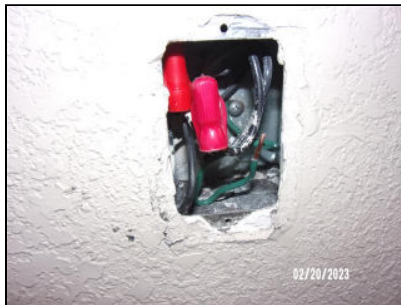
(2) Open electrical junction box(s) were found, which should be covered so that any arcing or sparking would be contained within the box - Attention.

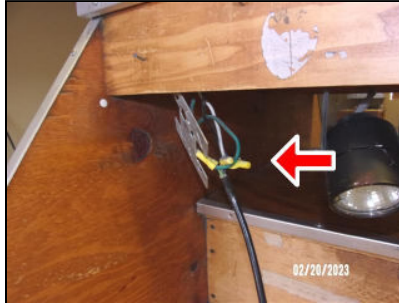
(3) Electrical connections (exposed splices) at the property have been incorrectly made outside of a junction box (potential fire-hazard) - Attention.

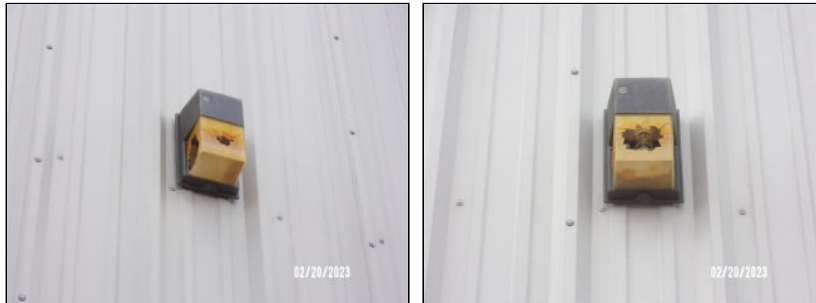
(2) Damaged light fixtures noted - Attention.

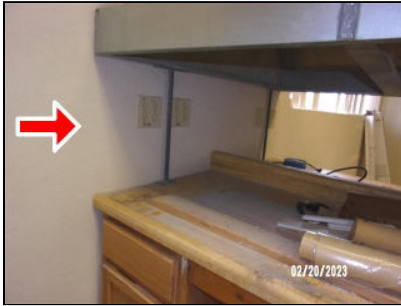
(2) Outlets did not operate under the east wall hood - Review/Consult Sellers.

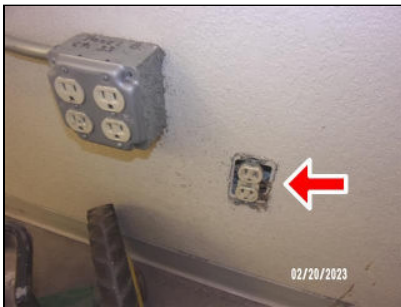
(3) Loose/missing outlet cover plates noted - Review.

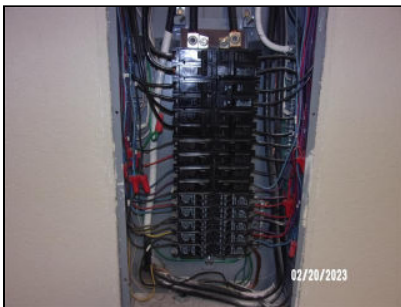
(1) The tree sub panels contained several breakers that had been switched off - Review/Consult Sellers.

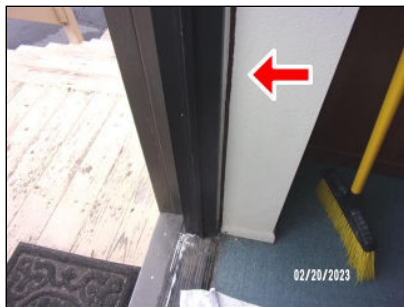
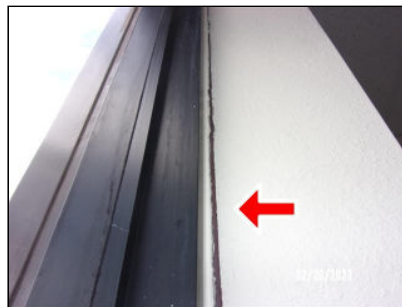
(4) Gap noted at the entry door frame and wall - Review.

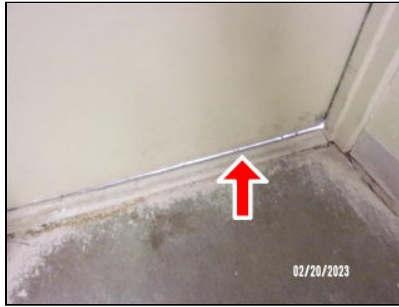
(5) Exterior door sweeps were missing - Review.

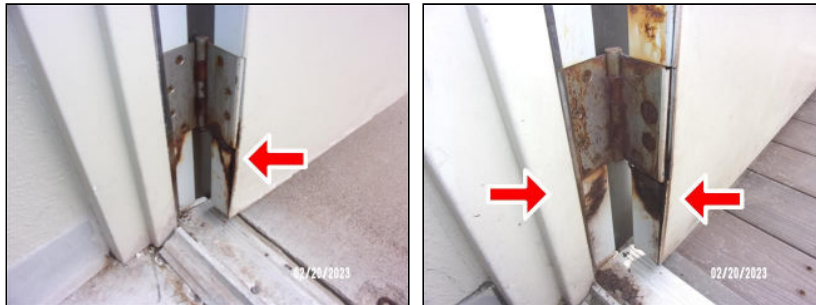
(6) Several rusted/damaged exterior doors noted - Review.

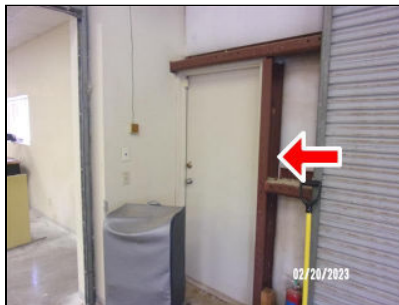
(7) The SE exterior door could not be operated - Attention.

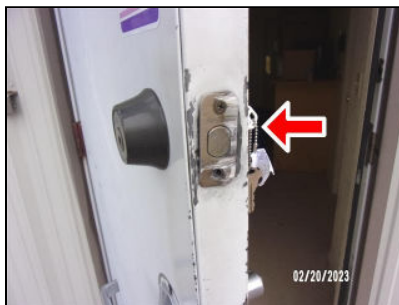
(8) Damaged exterior door hardware noted - Attention.

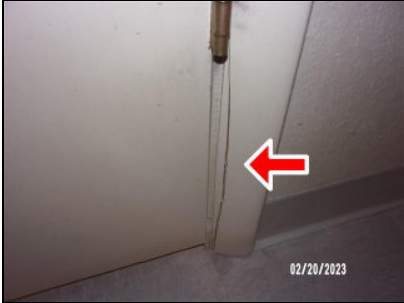
(3) Cracked Mens Room door frame noted - Review.

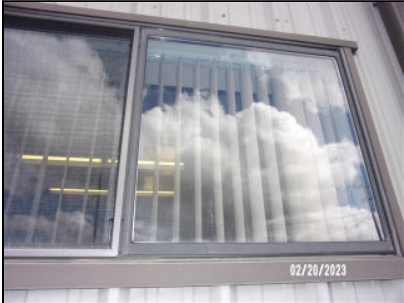
(2) Broken dual pane window seal(s) (fogged windows) observed (check all) - Review.

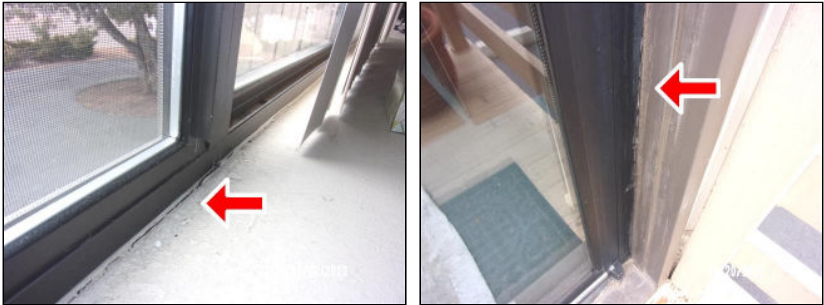
(3) Windows and doors should be resealed/recalulked around the interior perimeters - Review.

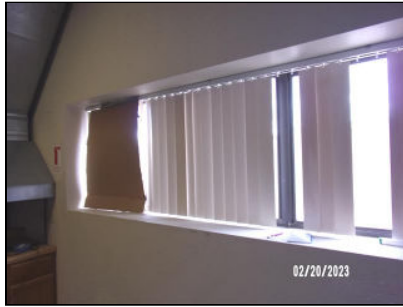
(4) Damaged window treatments noted - Review.

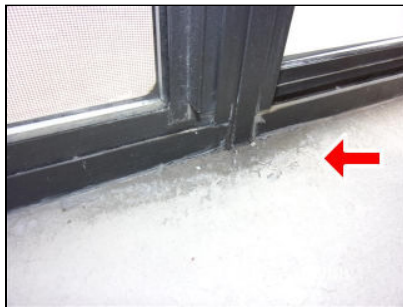
(6) Moisture stains/damage was observed at some window perimeters (check all) - Review.

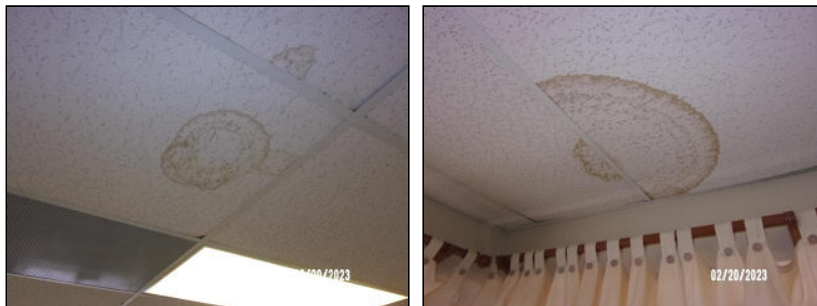
(2) Moisture stains noted at several locations - Review/Consult Sellers.

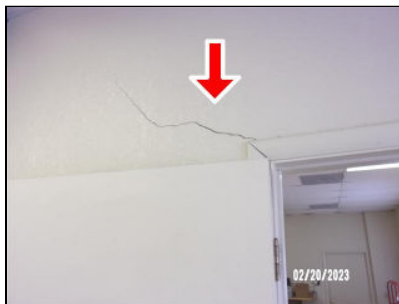
(3) Moderate interior wall/ceiling cracks noted - Review.

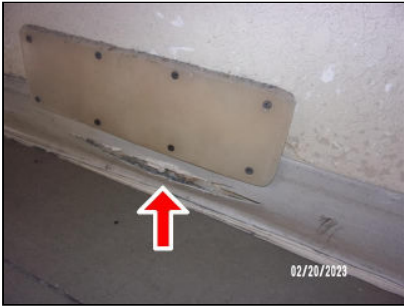
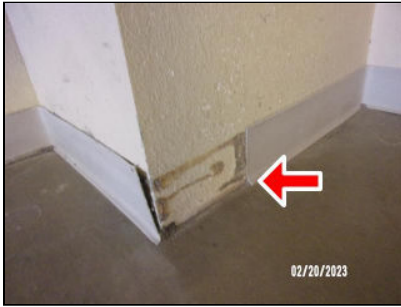
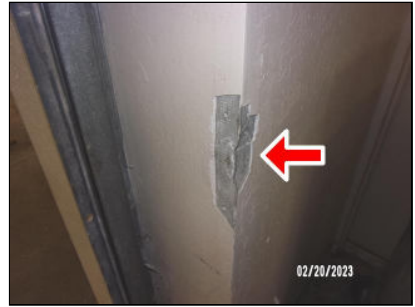
(4) Walls/ceilings have typical cosmetic issues noted - Review.

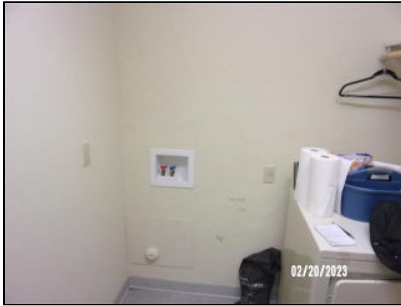
(5) Prior patching was observed at the north laundry room wall - Review/Consult Sellers.

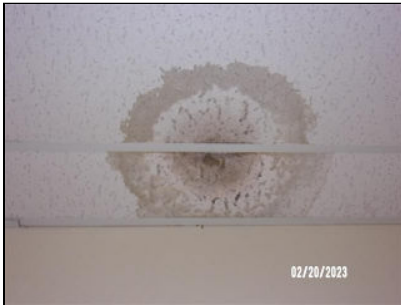
(6) Mold noted at the back room ceiling - Review.

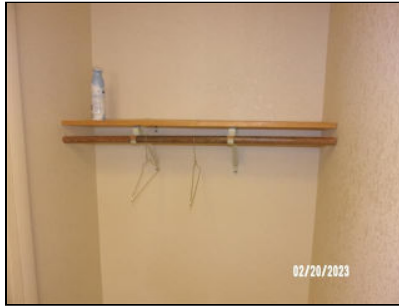
Loose closet shelf/clothes rod noted - Review.

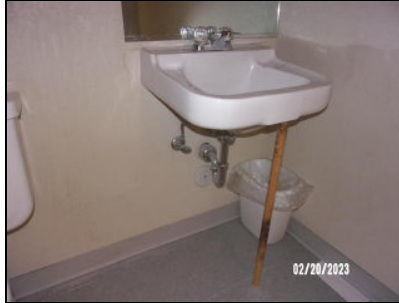
(2) The Mens Room bathroom sink needs securing/repair - Attention.
