## Inspection Report

Prepared For: New Home Buyer

Property Address:  
761 E. Main Street  
Gilbert AZ 85234

<b>Date:</b> 5/25/2023	<b>Time:</b> 01:30 PM	<b>Report ID:</b> 052523
<b>Property:</b> 761 E. Main Street Gilbert AZ 85234	<b>Customer:</b> New Home Buyer	<b>Real Estate Professional:</b> Christie Ellis Home Smart

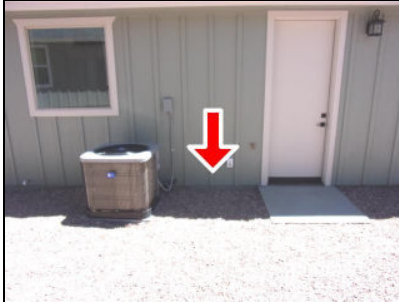
(1) Site drainage was poor on the north side near the HVAC unit, alterations are suggested to control water flow and keep it away from the building - Attention.

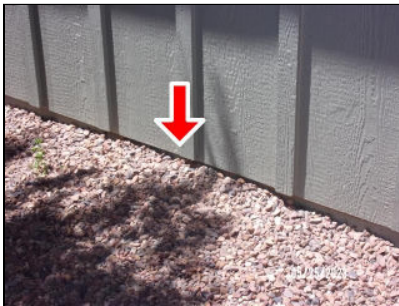
(2) Rock/soil was too high at the south structure perimeter - Review.

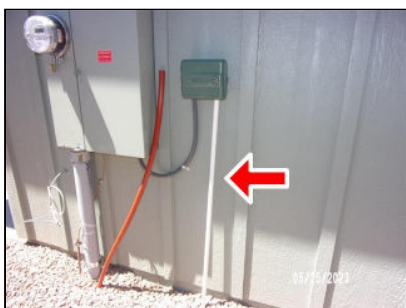
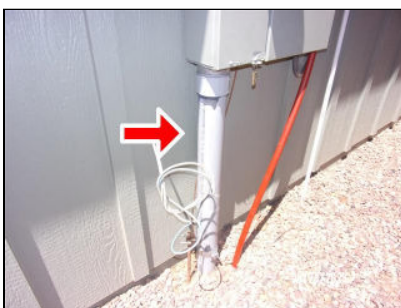
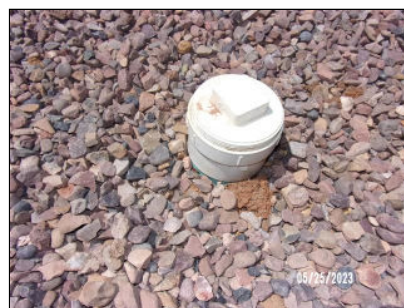
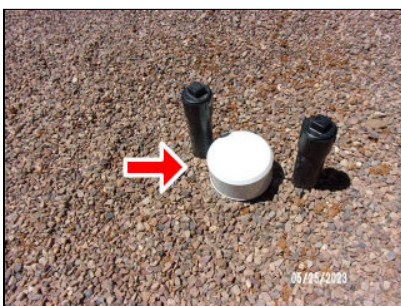
(1) Several pvc, conduit and plastic covers at the property should be painted to protect from the UV rays of the sun - Review.

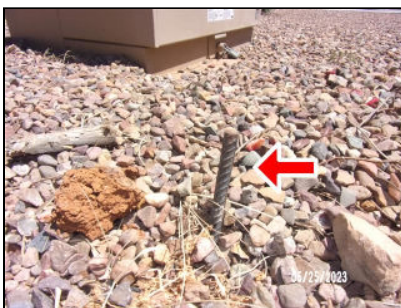
(2) Exposed protrusion/metal at the front yard are a cut/trip hazard - Review.

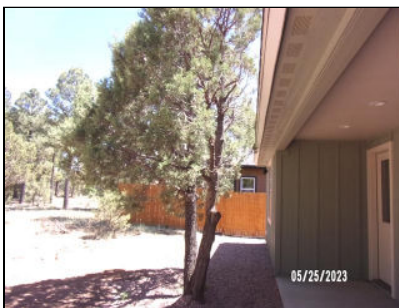
Trees/vegetation are located close to the structure foundation/roof - Monitor.

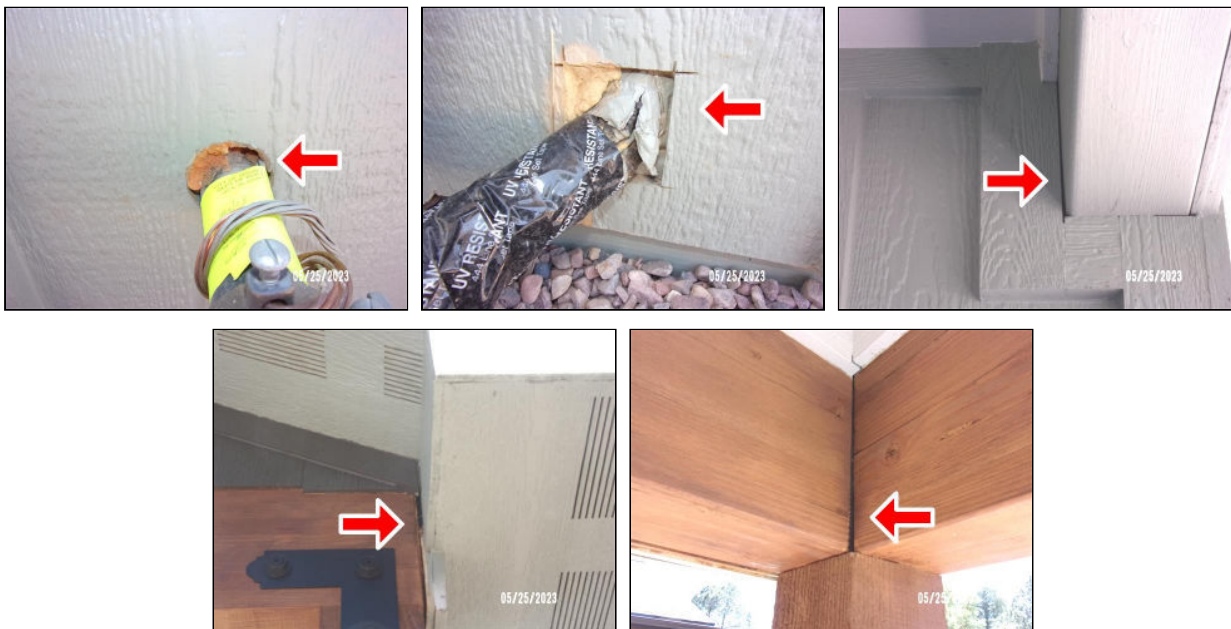
(1) Caulk/seal **all** gaps and openings at the exterior walls - Review.

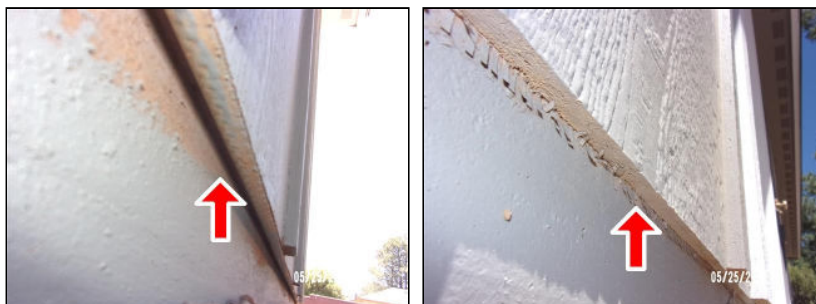
(3) Large gaps exist at the base of the wood siding on all sides of the house with exposed paper noted at several locations - Review.

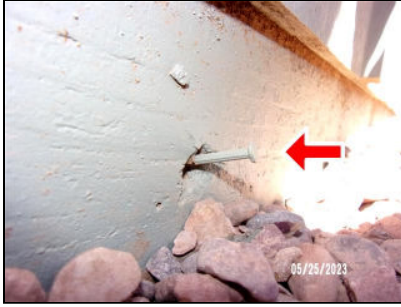
(1) Protrusion at the south stem wall should be removed - Review.

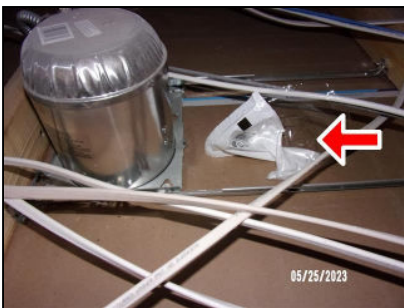
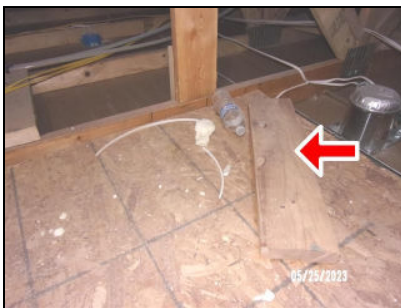
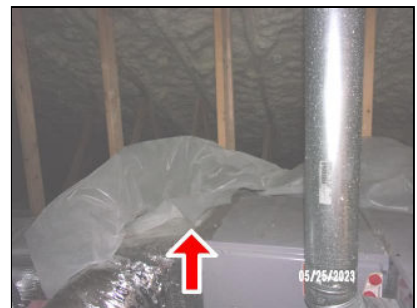
Debris found in the attic - Review.

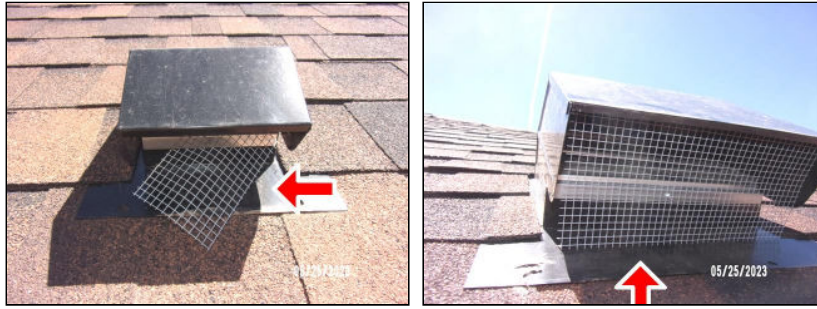
Loose/unsecured screens noted at the north and east roof vents - Review.

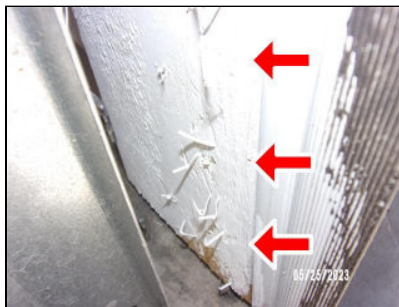
(1) Staples at the garage door frame in the garage are a cut hazard - Review.

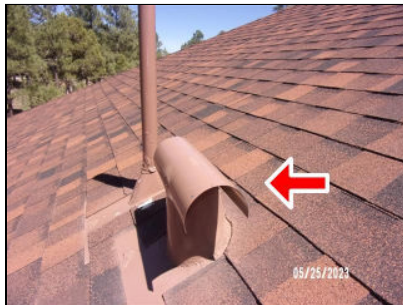
Older style dryer bonnet vent cap has been installed - Review/Consult Builder.

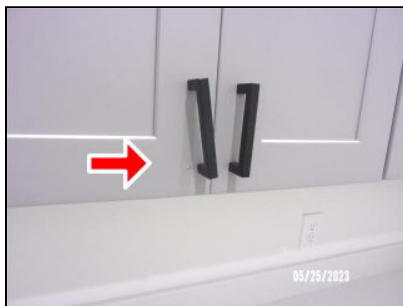
Loose laundry cabinet hardware noted - Review.

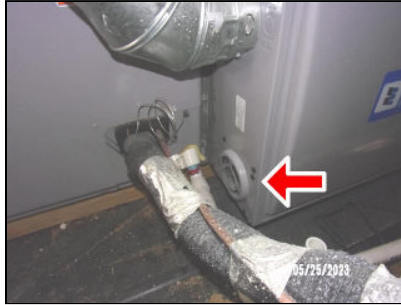
There are no combustion-air vents within the attic where the furnace is located to support combustion. This condition should be evaluated by the builder or an HVAC contractor - Review.

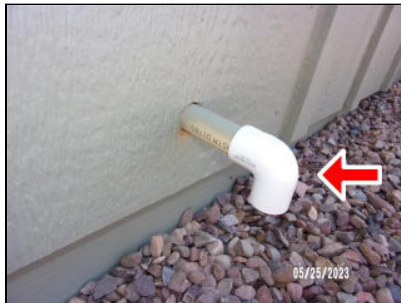
The condensate line termination should be painted - Review.

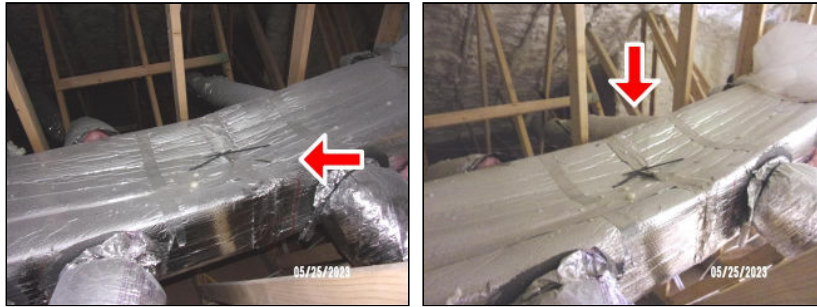
(1) The HVAC supply plenum in the attic is damaged. The box is normally square and appears crushed - Attention.

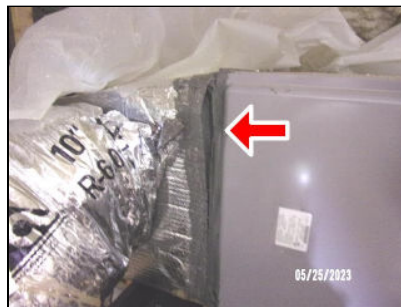
(2) Opening noted at the attic air handler - Attention.

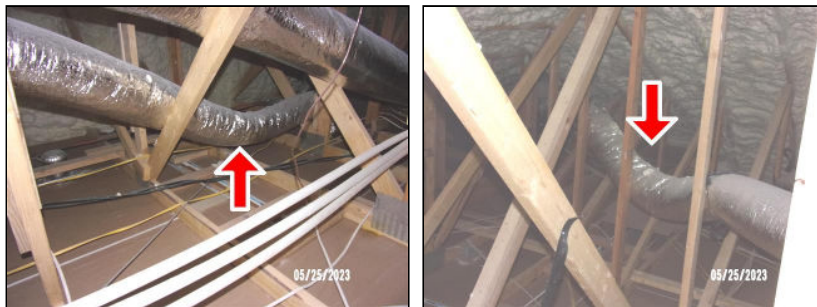
(3) Two supply air ducts in the attic do not appear to be properly supported - Review.

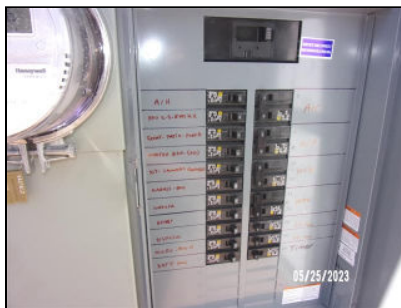
Arc fault breakers have not yet been installed and will be required on the final electric clearance from the city (per my conversation with the city of Gilbert code enforcement) - Review.

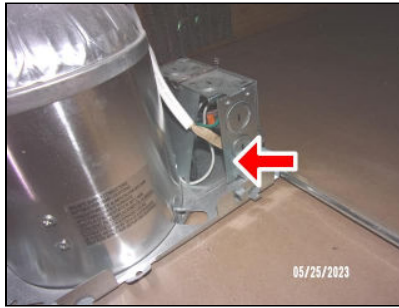
Loose/open electrical junction box noted under the attic HVAC unit - Review.

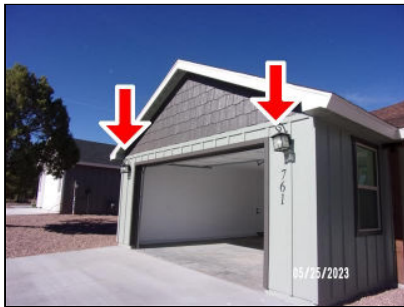
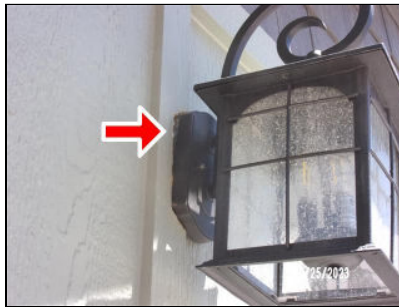
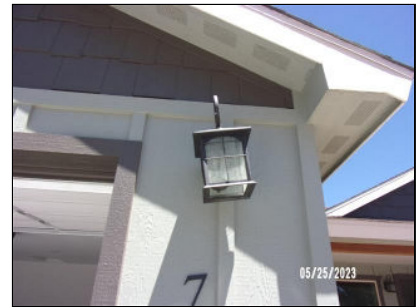
Loose carriage lights noted at the garage exterior - Review.

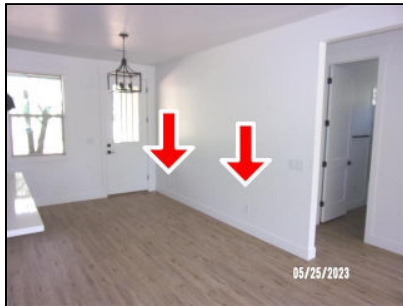
(2) Two inoperative outlets found in the dining area (see stickers) - Attention.

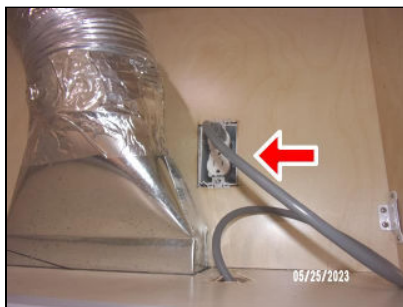
(3) Missing outlet cover plate noted above the microwave - Review.

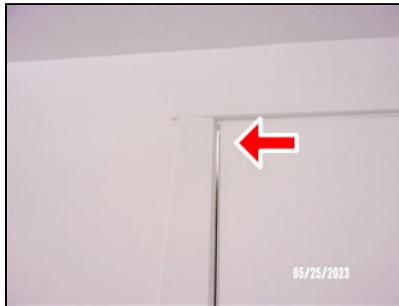
(2) Poor seal noted at the garage side service door - Review.

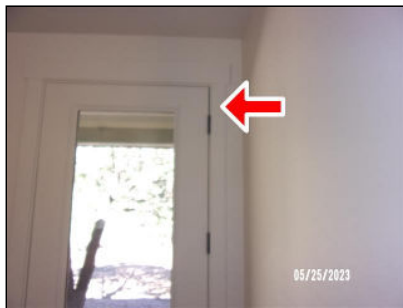
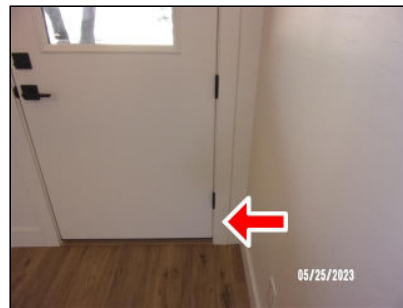
(1) Interior and exterior door stops are missing, install as required - Review.

(2) Many interior and exterior door margins are wide and need adjustment. There is a lot of play at many of the interior doors when they are closed and latched - Review.

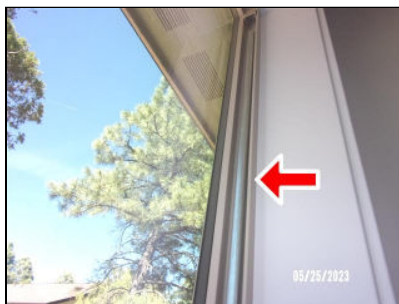
(1) The spring at the NE master b/r window is not properly attached - Attention.

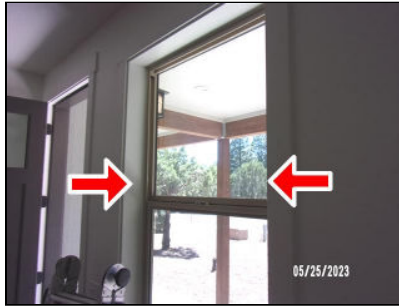
(2) The south family room window film is delaminating - Review.

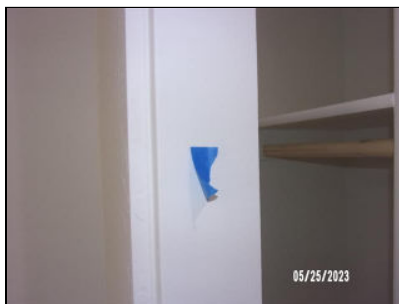
Fit/finish is not yet complete - Review.

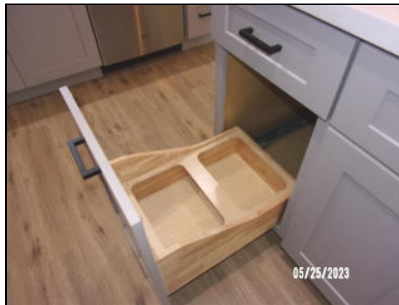
(2) The kitchen garbage cans have not yet been installed - Review.
