Inspection Report

**Property Address:
123 Fairways Drive Lot #998
Scottsdale AZ 85138**

Inspected By: Timothy O'Neill, ACI

Date: 3/14/2023	Time: 08:30 AM	Report ID: 031423
Property: 123 Fairways Drive Lot #998 Scottsdale AZ 85138	Customer: John Smith	Real Estate Professional: Janell Ward

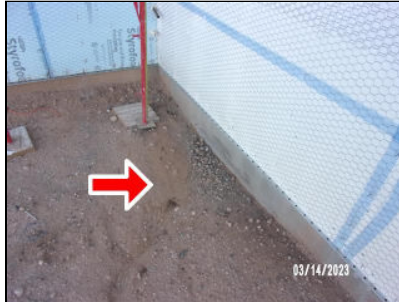
(1) Drainage should be improved at the north exterior.

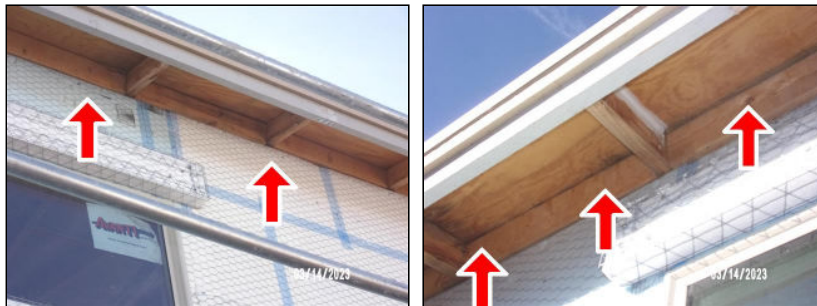
(1) Openings should sealed/caulked at the trim.

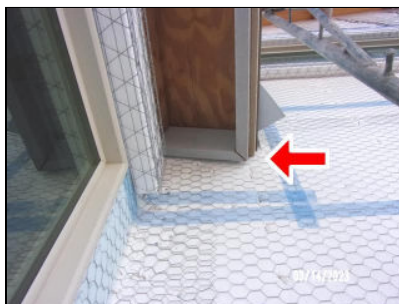
(2) Missing west trim tie noted.

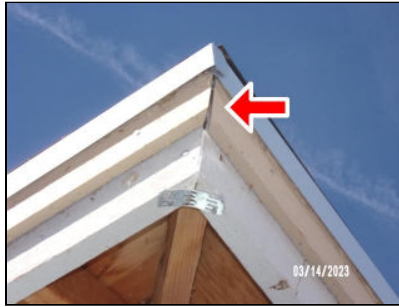
(3) Caulking needed at various trim locations.

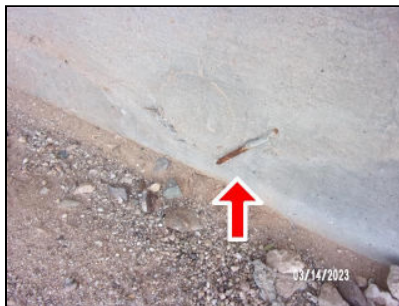
(1) Protrusions at the stem wall should be removed.

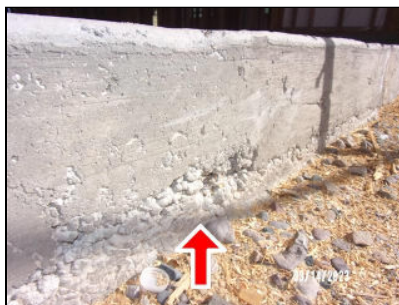
(2) Garage stem wall should be sealed.

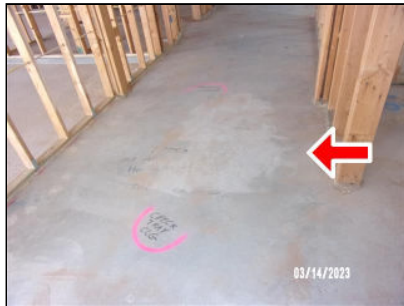
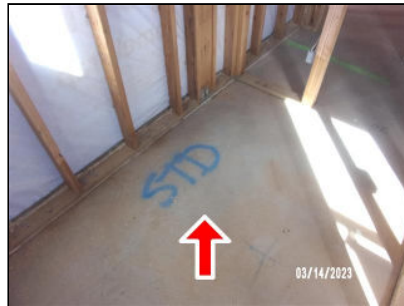
(4) Lifted/uneven flooring areas noted at the foyer and se-b/r closet.

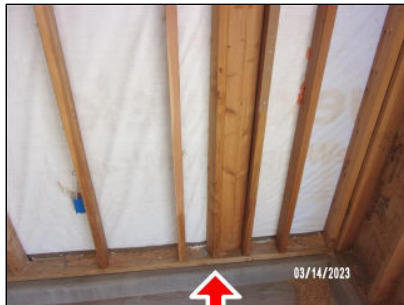
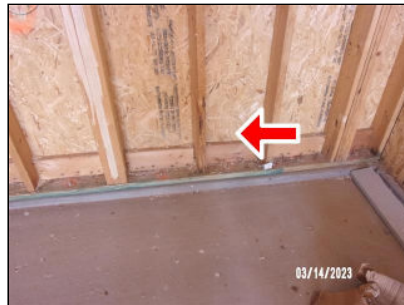
(1) Many twisted/warped studs noted at various locations.

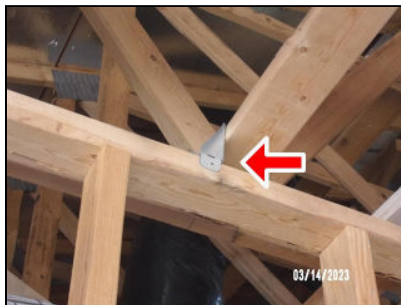
(2) Missing nails at the bearing point straps.

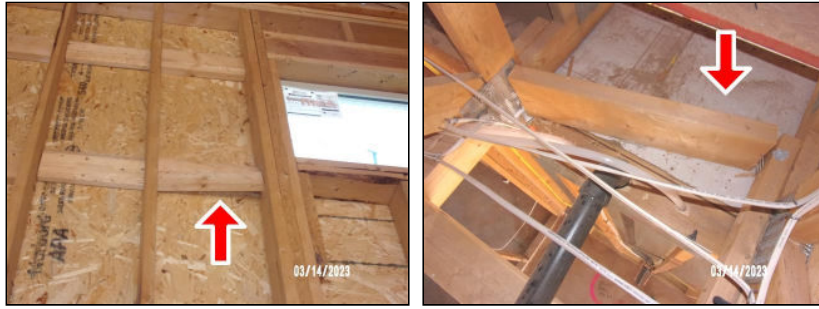
(3) Unsecured blocking noted at the garage and attic scuttle.

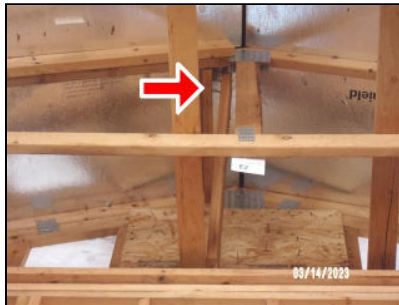
(4) Unsecured diagonal strut noted at the north large garage.

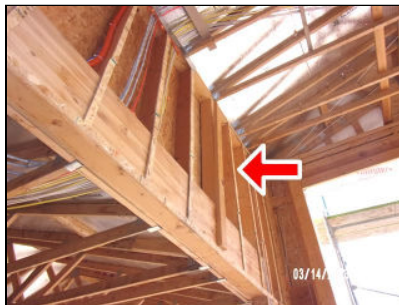
(5) Extra wood should be removed at the east large garage wall.

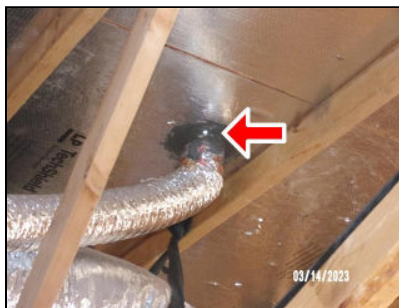
(6) All roof penetrations should be re-sealed/capped.

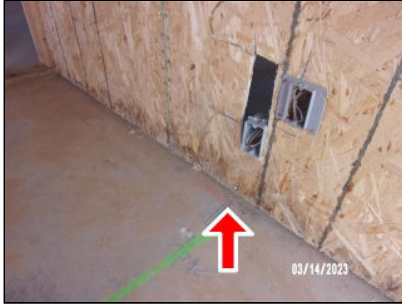
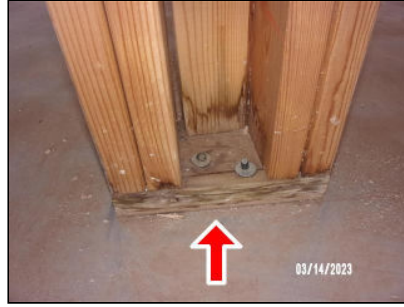
(7) Significant stained framing noted throughout the house.

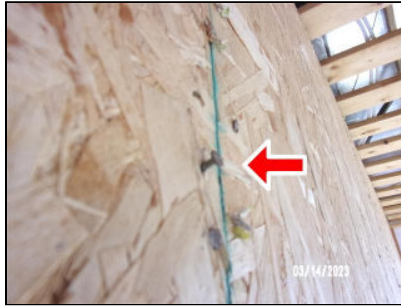
(8) Framing fasteners need securing.

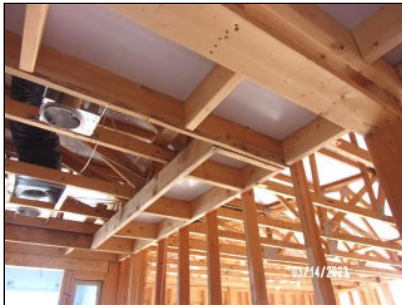
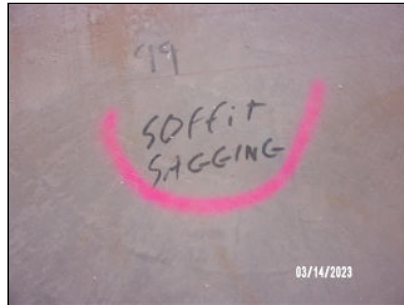
(9) Foyer soffit still appears to be sagging.

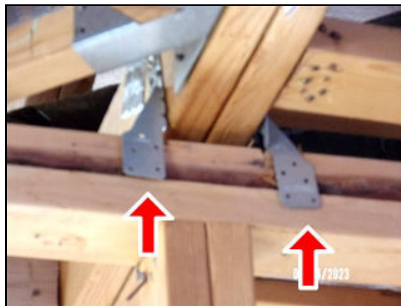
(10) Missing nails noted at straps in the se-b/r.

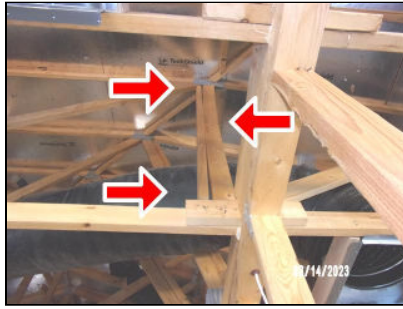
(11) Separation/deflection noted at the west family rm. vertical truss.

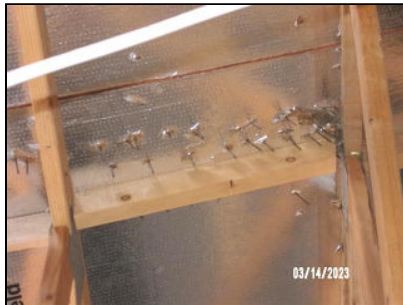
(12) Nailing missing the mark noted at several roof sheathing locations.

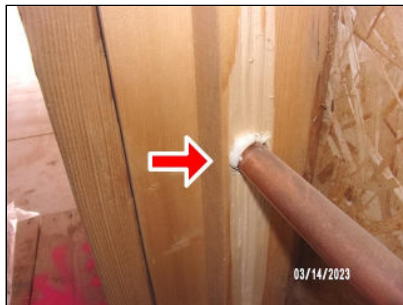
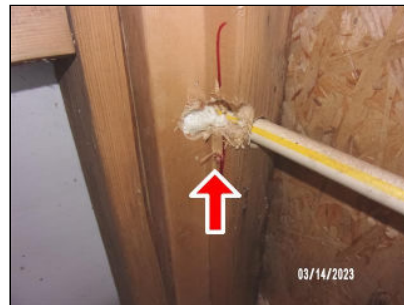
(13) Missing nail guards at the water heater pipes.

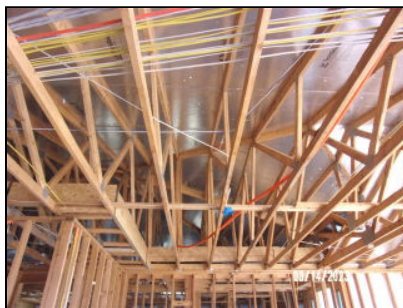
(14) Many trusses are not plumb.

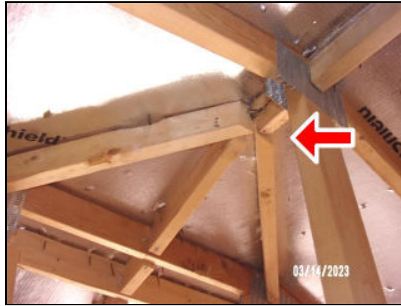
(16) Mid roof framing appears to be loose/unsecured.

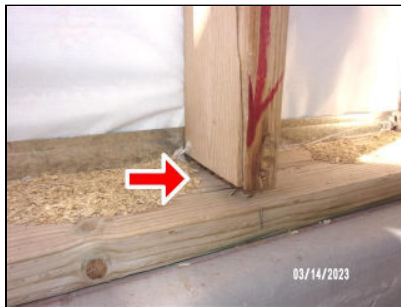
(17) SW large garage stud does not fully connect with the sill plate.

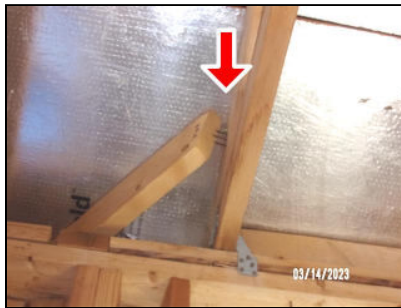
(18) Some framing members are not secured.

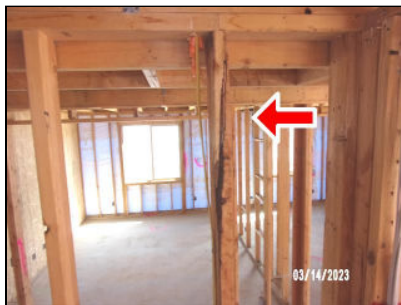
(19) Damaged stud at the east laundry room should be replaced.

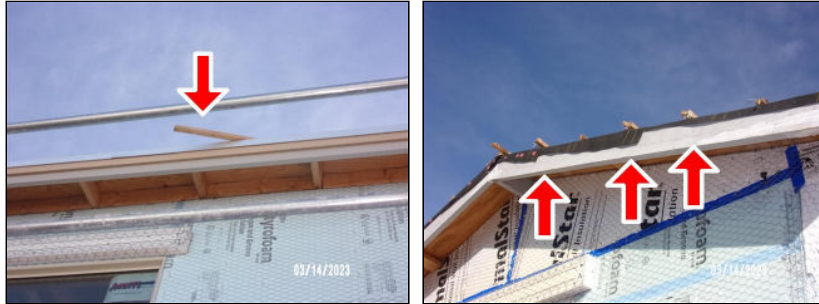
(1) Battens are unsecured/damaged at the roof.

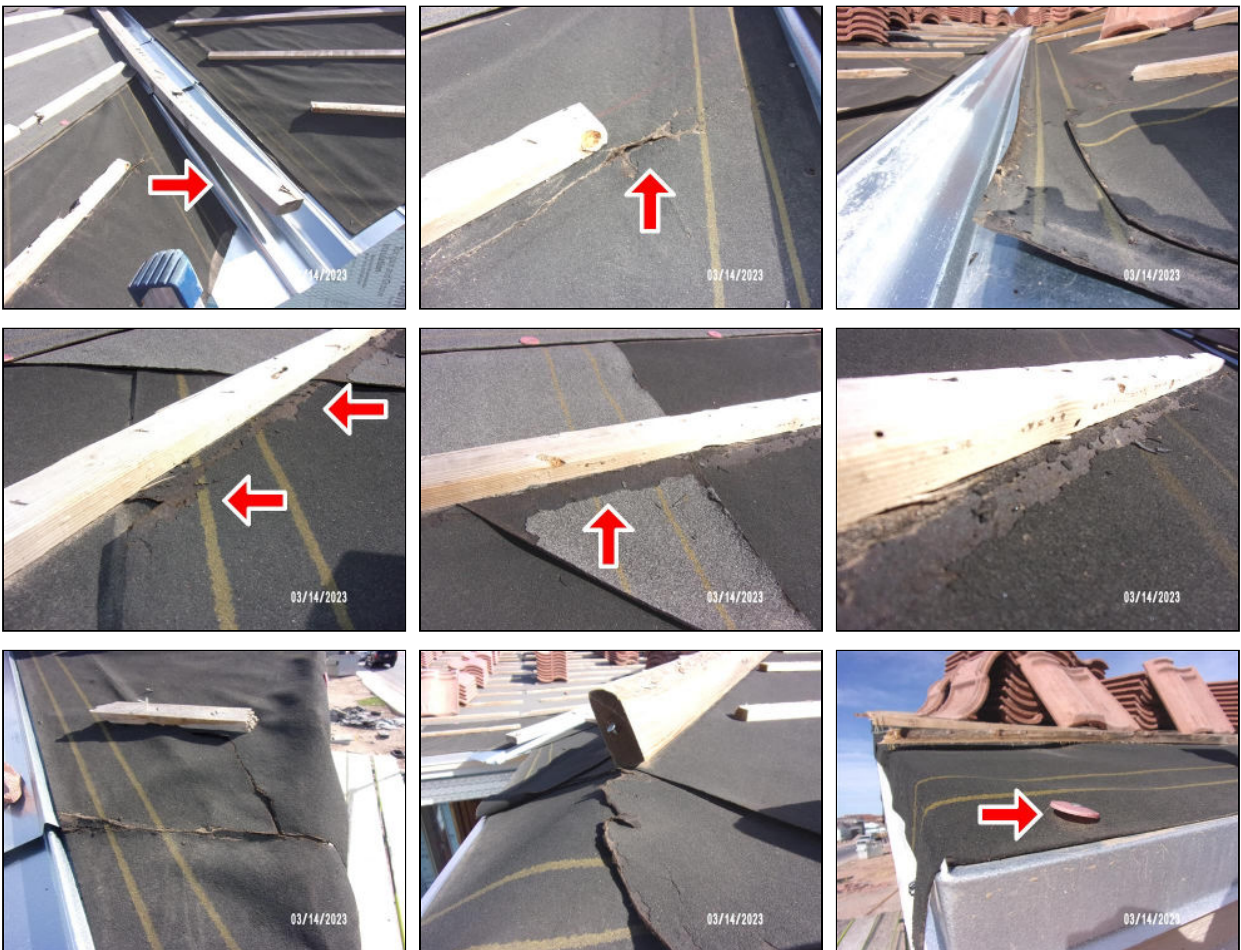
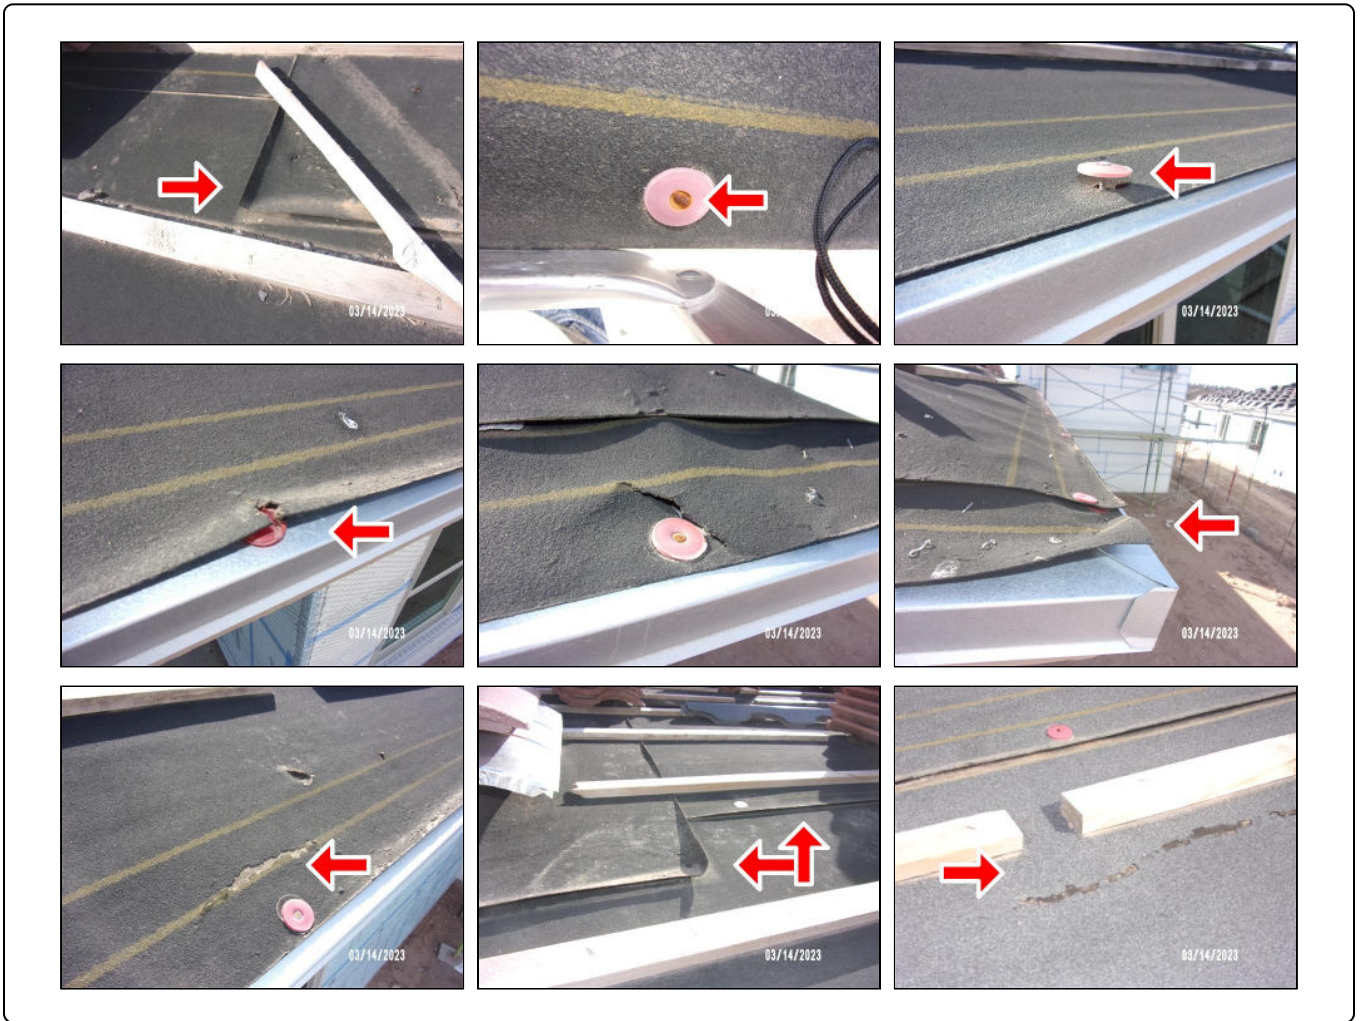
(2) The roof needs complete evaluation/replacement due to damaged battens/blocking, damaged/deteriorated underlayment, loose/damaged fasteners and overall sun damage.

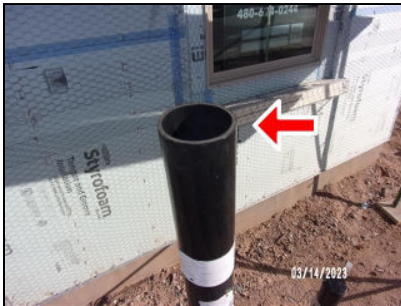
(1) Cap missing at a front clean out.

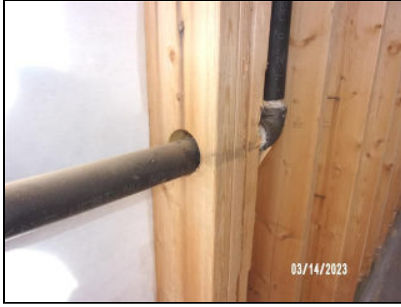
(2) Missing nail guard(s) at the large garage gas pipe.

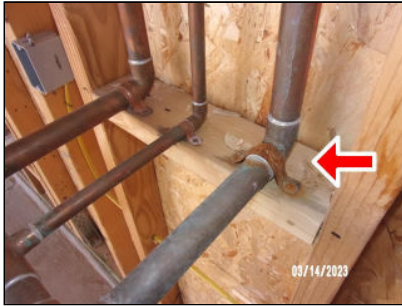
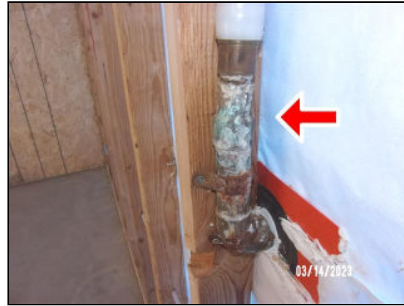
(3) Rust/corrosion noted at the pipes/straps at the water softener and water main.

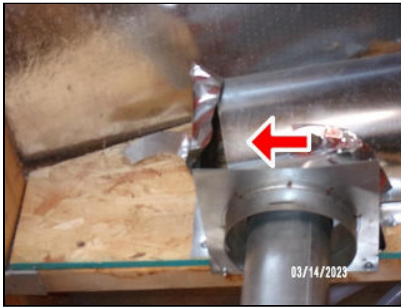
(4) Loose/unsecured water heater flue cover noted.

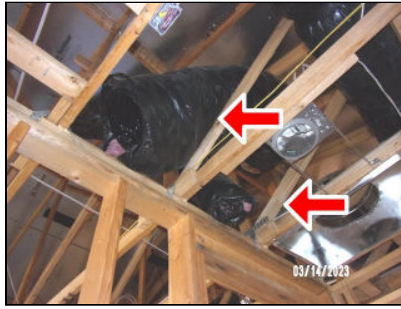
(1) Unfinished/incomplete HVAC ducts noted.

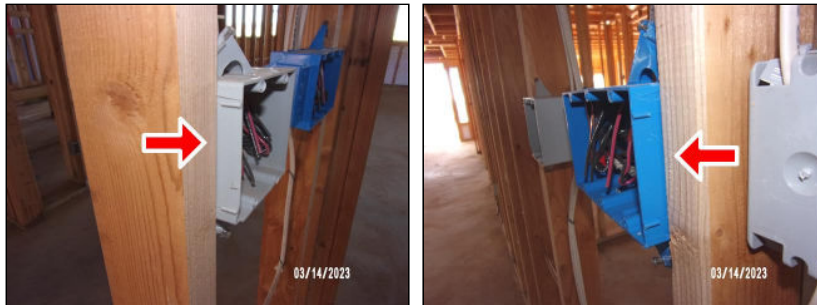
(1) Switch boxes are not properly placed at the north hallway.

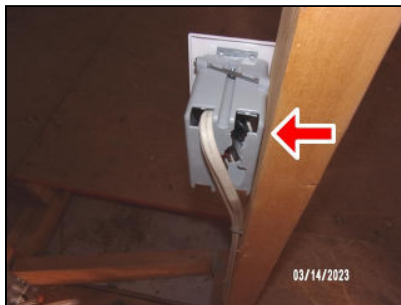
(2) Damaged attic outlet box noted.

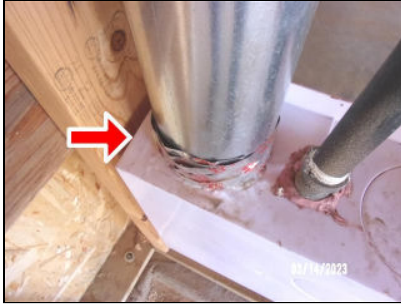
(1) The dryer vent should be re-wrapped.

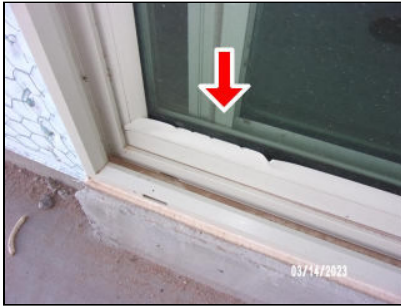
(2) Damaged trim noted at the arcadia door.
