## Inspection Report

Prepared For: New Home Buyer

Property Address:  
761 E. Main Street  
Gilbert AZ 85234

<b>Date:</b> 5/25/2023	<b>Time:</b> 01:30 PM	<b>Report ID:</b> 052523
<b>Property:</b> 761 E. Main Street Gilbert AZ 85234	<b>Customer:</b> New Home Buyer	<b>Real Estate Professional:</b> Christie Ellis Home Smart

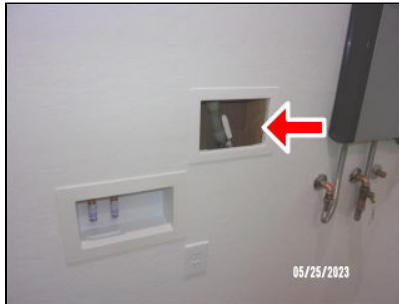
The supply piping appears Satisfactory where visible at meter and riser areas (underground sections not identified or evaluated). Main shut off in the laundry room.
