## Inspection Report

**Property Address:  
123 W. Main Street  
Phoenix AZ 85020**

**Inspected By: Timothy O'Neill, ACI**

<b>Date:</b> 2/20/2023	<b>Time:</b> 12:00 PM	<b>Report ID:</b> 022023Main
<b>Property:</b> 123 W. Main Street Phoenix AZ 85020	<b>Customer:</b> Business Buyer	<b>Real Estate Professional:</b> Benjamin Hernandez

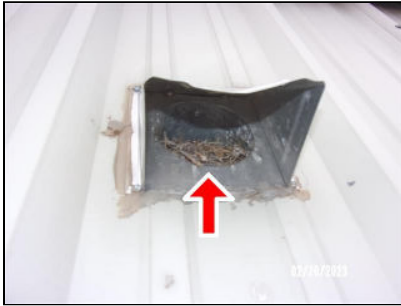
(3) Birds roosting in an east sidewall vent - Review.

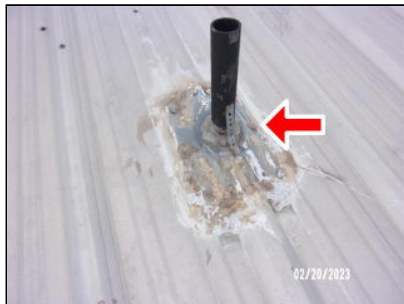
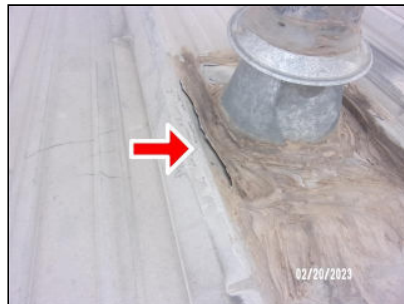
(2) Flashing separations need correction at various roof locations - Attention.

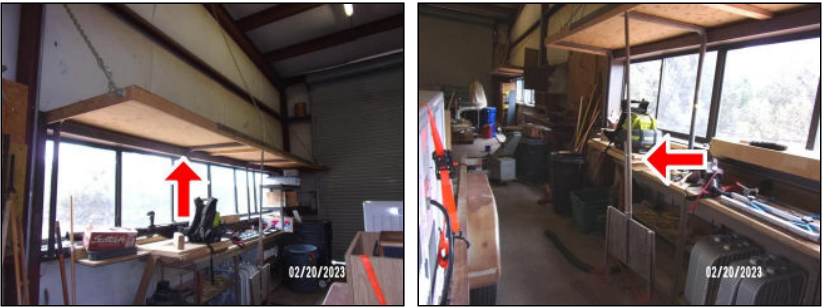
Garage storage provisions need complete review before use - Attention.

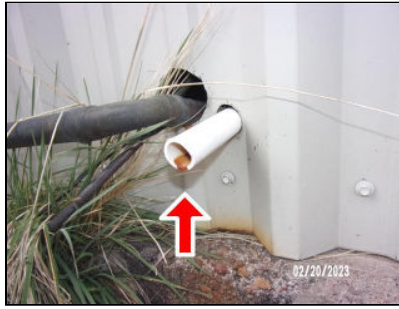
(1) The condensate line(s) need a 90 degree elbow at the termination location - Attention.

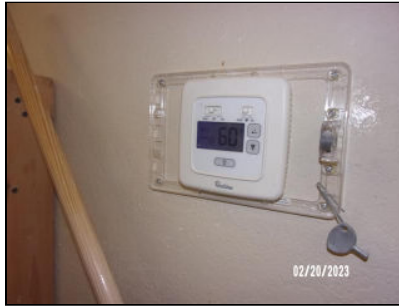
(2) Difficult to operate the south thermostat - Review.

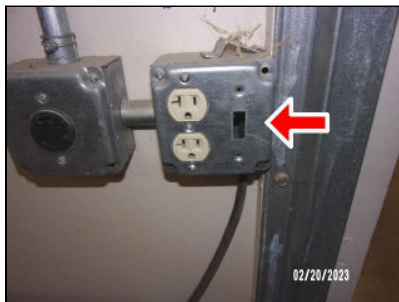
Missing switch/open junction box noted in the garage - Review.

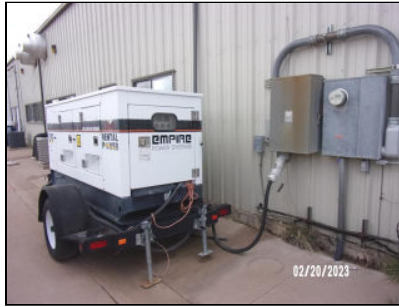
The generator was not part of this inspection - Review.

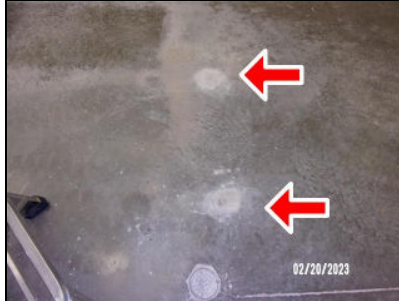
(3) Prior flooring repairs noted - Review

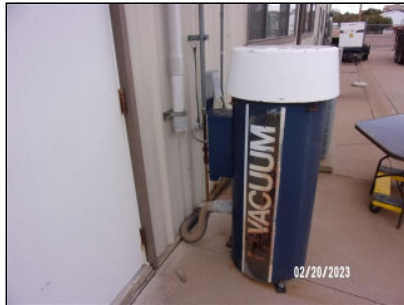
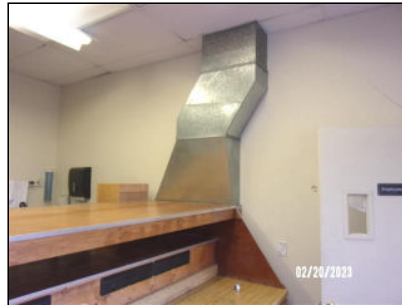
(2) Vacuum and vent hoods present but is not part of this inspection - Review.

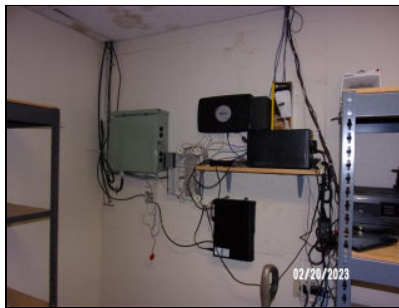
(3) Phone system present but is not part of this inspection - Review.
